SB005

Diesel Piston Crown Erosion

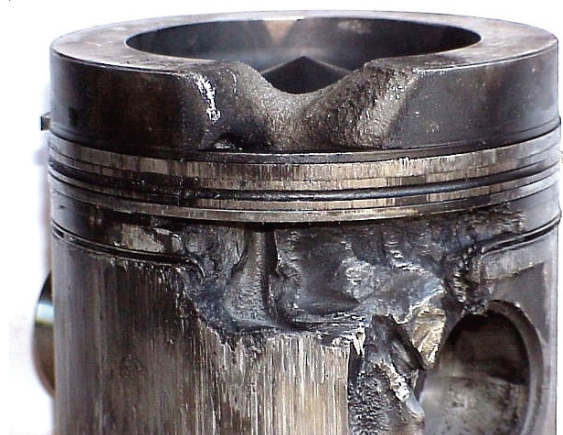
A malfunction, or the incorrect adjustment of the fuel injection system will often cause fuel to wet the combustion chamber surfaces (Figures 2 to 4). When this happens, the fuel burns in direct contact with the surfaces without the protective boundary layer being present. The rate of heat transfer from the combustion gases increases dramatically and temperatures rapidly exceed the melting point of piston alloys. Piston crown erosion inevitably follows.

The illustration shows a typical example of crown erosion and melting. An unatomised fuel spray acts like a 'flame thrower', melting and blasting through the crown of the piston. A mixture of molten crown alloy and burning diesel has eroded and melted behind the Alfin insert and exited out through the oil ring groove and down the skirt.

When crown erosion is discovered in a diesel engine, make an immediate and thorough check of the whole fuel injection system. A piston alloy has not yet been invented that will resist fuel burning on its surface, and blaming the component's metallurgy will simply delay identification of the true cause - a fuel injection system malfunction.
