SB011

Cavitation Erosion

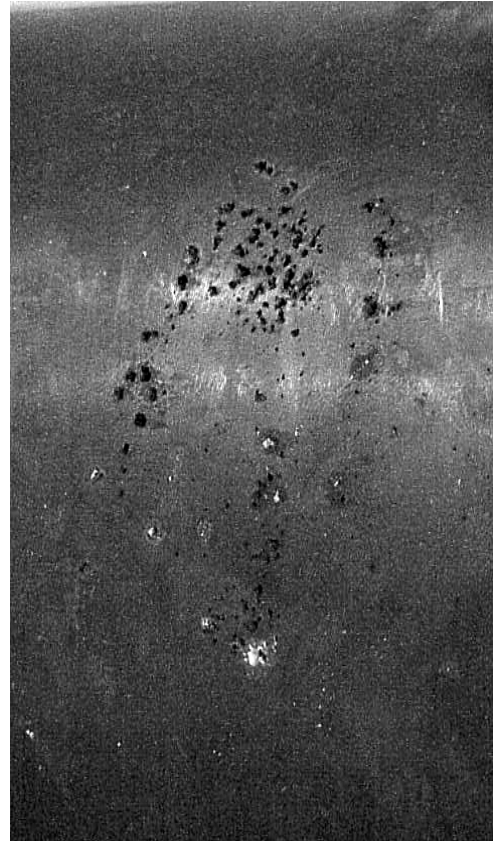
Cavitation erosion typically occurs in a vertical band on the outside diameter of the sleeve, matching the major thrust side of the piston. It also often occurs around the liner 'o' ring sealing lines. There are three general causes of the phenomenon:

- high frequency sleeve wall vibration
- stagnant water pockets in the cooling system
- air leaks in the cooling system

- Ensure correct cooling system conditioner levels
e.g. corrosion inhibitor, antifreeze, anti-foam.
- Ensure correct cooling system pressures by fitting the correctly rated radiator cap and checking the radiator cap is working correctly.
- Only use distilled water in the cooling system.
- Ensure the sleeve fit is correct.
- Apply special protective coatings to the water jacket region of the sleeve outside surface
e.g. chrome, copper, plasma, ceramic.
- Ensure there are no air leaks in the cooling system.
- Correctly bleed the cooling system when filling to ensure there are no trapped air pockets.
