SB017

Valve Stem Bending and Fatigue Fracture

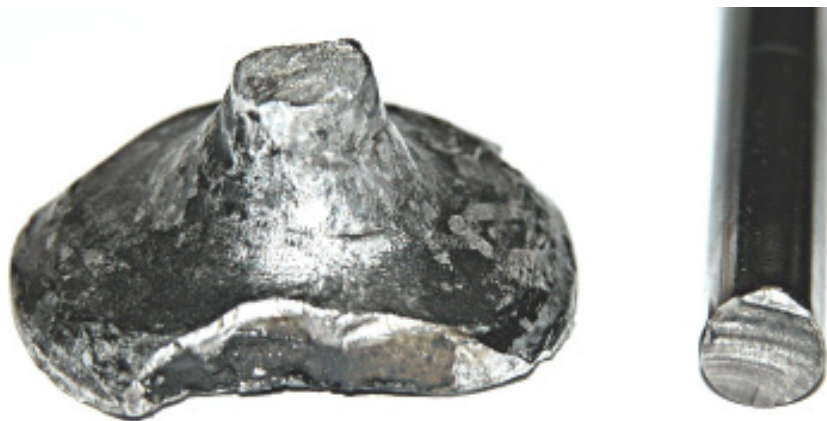
Valve stem fracture (VSF) usually results in considerable and expensive engine damage - especially in the now common double overhead cam, four valve per cylinder design engines. The cause of VSF is rarely a manufacturing or materials fault and nearly always an operational fault. Table 1 below shows a summary of fracture faces of shafts and a valve stem is fundamentally a shaft. The majority of VSFs are due to one way bending, although two way bending and reversed bending by rotation can also occur. The most common stem fracture appears as a valve head to stem breakage in the region of the junction of the underhead radius and the stem (Photo 1). Even when the stem is a welded two piece design, this type of fracture does not occur at the weld, but typically closer down towards the head. The stem is often drawn up into the head and the fracture face remains undamaged, while the valve head typically drops into the cylinder and is too damaged for the fracture face to provide evidence.

Photo 1. Typical valve stem fracture at the underhead radius and stem junction. The stem fracture face is usually in good condition, while the valve head fracture face is typically too damaged to be of use.

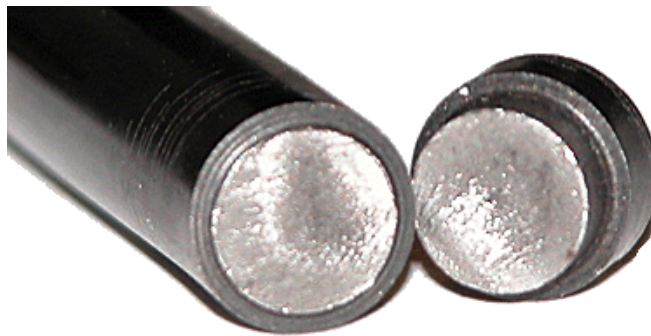
Valve stem breakage through a single collet groove can be caused by any of a number of conditions. Some of these are faulty keeper installation, damaged collet groove, valve bouncing, valve spring coil bind and damage at assembly from 'bouncing' the valve on its seat after fitting - usually with a soft mallet. One example of fracture through the collet groove due to high overstress can be seen in Photo 2 below.

Photo 2. Valve stem fracture at the collet groove. The fracture shows no sign of cyclic fatigue, but the stem end is bent and the fracture face is typical of high overstress.
