## SB018

# Valve Face Wear or Guttering and Valve Head Tuliping/Cupping

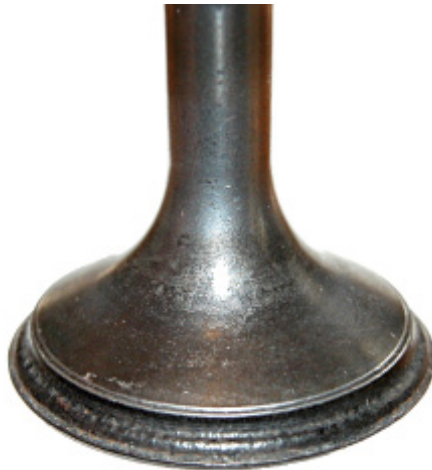
This is usually not a problem with modern engines, as its occurrence will usually have been identified and corrected during development by the engine manufacturer. The problem is corrected by the appropriate choice of valve seat and valve face materials (e.g. stellite) and improved valve geometry. On earlier engines without hard faced seats, high engine temperatures, coupled with slack tappets or weak valve springs can result in valve face pounding and wear. Misaligned valve seats and valve stems can also cause this sort of wear. Normally, the exhaust valve is adequately lubricated by the products of combustion. However, lead free and LPG fuels result in drier and lubrication free exhaust gases, which causes increased valve face wear as a result of micro-welding between the valve face and seat. The typical appearance of valve face wear or guttering can be seen in Photo 1.

This is a problem that is peculiar to the turbocharged diesel engine (but not turbocharged petrol engines) and typically in engines on constant or continuous duty cycles (e.g. marine engines, power generator engines, stationary engines etc.). Turbocharging increases the pressure developed during the induction stroke and air pressure in the inlet port above atmospheric pressure. This prevents any lubricating oil being taken into the air stream from the valve guide. Consequently, the valve face and seat run dry and wear can occur on either, although in practice, mainly on the valve face. Although similar conditions occur in turbocharged petrol engines, inlet valve and seat lubrication is provided by the wet fuel. Engine manufacturers spend considerable time researching and ensuring this type of valve wear does not occur. Again, the problem is corrected by the appropriate choice of valve seat and valve face materials (e.g. stellite) and improved valve geometry.

Photo 1. Valve face wear or guttering.

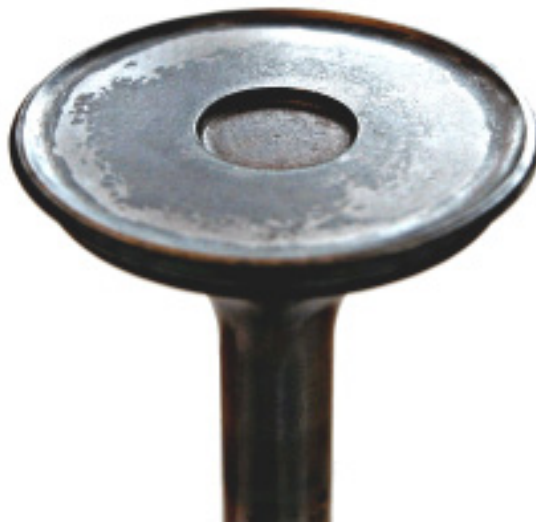
If the valve face wear results in the valve head edge being excessively thin and/or the valve head has been exposed to excessive engine temperatures resulting in loss of yield strength, the valve head may 'cup' or 'tulip'. The typical appearance of valve head cupping/tuliping can be seen in Photo 2. Cupping can also be the result of extreme mechanical stresses typical of excess spring loads from over revving or incorrect installed valve spring heights. Undetected, this condition can result in chordal cracking or burning of the valve head and contact between the valve and piston - particularly in diesel engines where the valve head to piston crown clearance is minimal.

Photo 2. Valve head cupping or tuliping.
