## SB027

### Valve Guide and Stem Wear

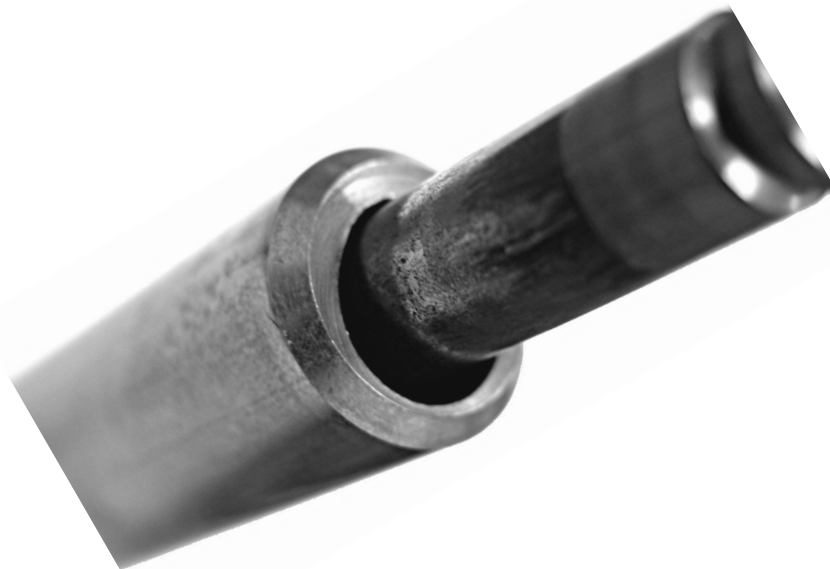
Excessive valve guide and stem wear can occur on both inlet and exhaust valves. It is usually more prevalent with exhaust valves and can be caused by a number of factors. The effective sealing of a valve and valve seat is governed by the correct alignment of the valve in the guide and the concentricity of the valve seat and valve guide. A correctly fitted and sized valve guide accounts for approximately 25% of the heat transfer from the valve. In most cases, the valve stem and tip will experience considerable side thrust from either the camshaft or rockers. If any of these conditions are incorrect, excessive valve guide and/or valve stem wear and scuffing will occur.

The most likely causes of excessive valve guide and/or stem wear are:

- Excessive valve stem to guide clearance, resulting in guide 'bell-mouthing'.
- Insufficient valve stem to guide clearance, resulting in stem and guide wear and/or scuffing.
- Excessive carbon build-up on the valve neck and adjoining stem, resulting in stem scuffing.
- Insufficient or a breakdown of valve stem lubrication, resulting in stem scuffing and scoring.
- Abrasive particles contaminating the valve stem and guide bore, resulting in accelerated wear.
- Incorrect valve seat and valve guide alignment, resulting in extreme side loading on the stem and flexing of the valve neck and stem.
- Incorrect rocker to valve tip geometry, resulting in excessive side loading.
- Insufficient oil supply when starting a cold engine in subzero temperatures.
- A bent valve stem.
- A badly worn valve tip, resulting in excessive side loading.
