Boost Pressure vs. Blow-by

Diesel Performance Parts ring sets with Total Seal Gapless 2nd Ring Technology

(Research and testing by Brandon Peltz and Brett Harth, Engine Australia)

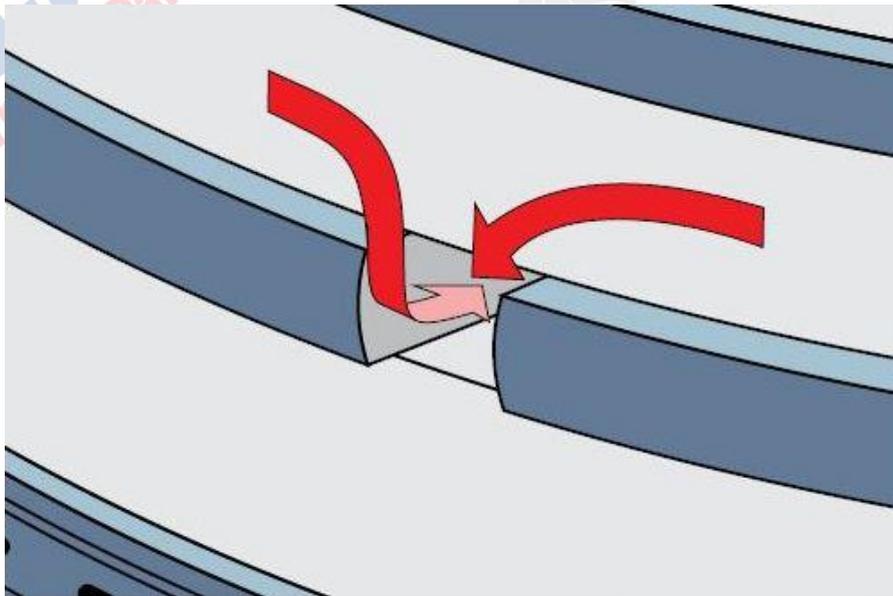
Combustion gas leakage through the top ring gap is essential to the correct operation of the second ring. Once the gas escapes past the 2nd ring it no longer serves any purpose and becomes a loss.

If all these factors are catered for and the engine is run-in correctly, you will have the best chance of minimal blow-by, which is measured in LM (Litres per Minute) or CFM (Cubic Feet per Minute). Even with all these factors under control, combustion gases will leak through the ring gaps. Top and 2nd rings have very low ring tensions and rely on combustion gases entering behind the rings and forcing them out onto the bore walls. The oil ring on the other hand has very high tension and relies on that to seal with the bore and control the amount of oil that gets to the 2nd and top rings.

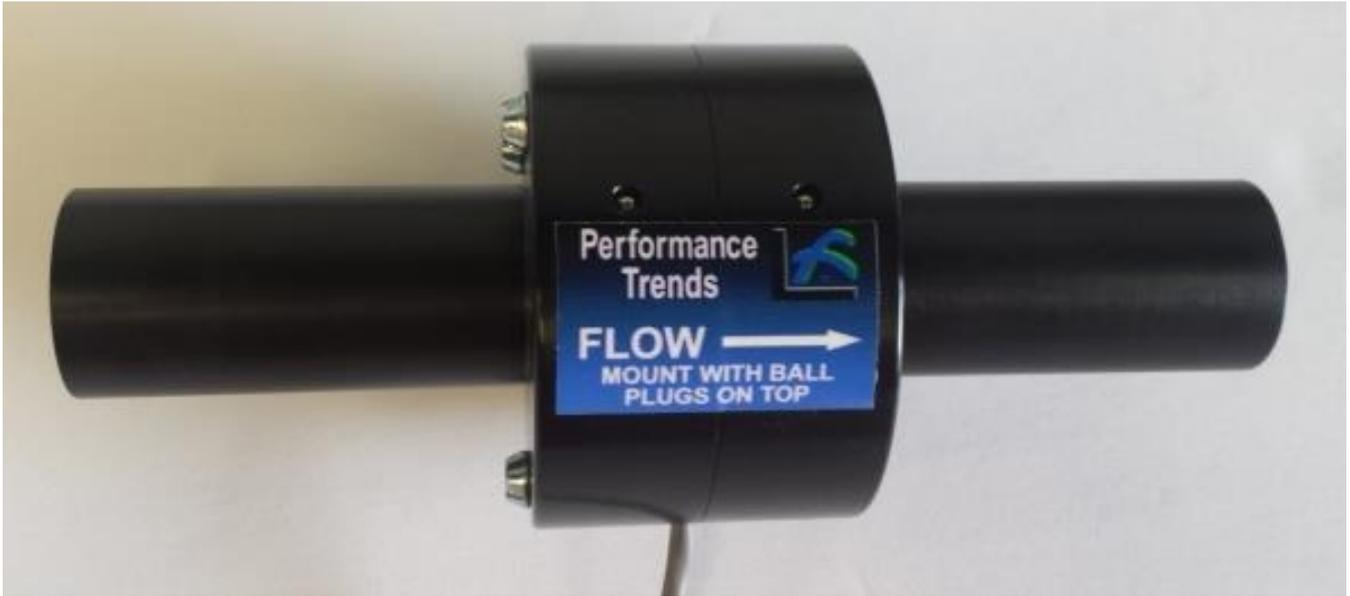
Performance Trends Blowby Sensor

The Engine Australia R&D Workshop uses a Performance Trends Blowby Sensor to measure CFM flow from the crankcase during chassis dyno testing. The Sensor has been wired and coded to the DynoDynamics control software that enables us to pair the results with any other variable being monitored e.g. power, torque, inlet manifold boost, RPM, etc. The sensor is fitted to a hose attached to the crankcase breather. While not ideal, it can be attached to the catch can breather outlet if the engine has a serious oil problem from the crankcase breather.

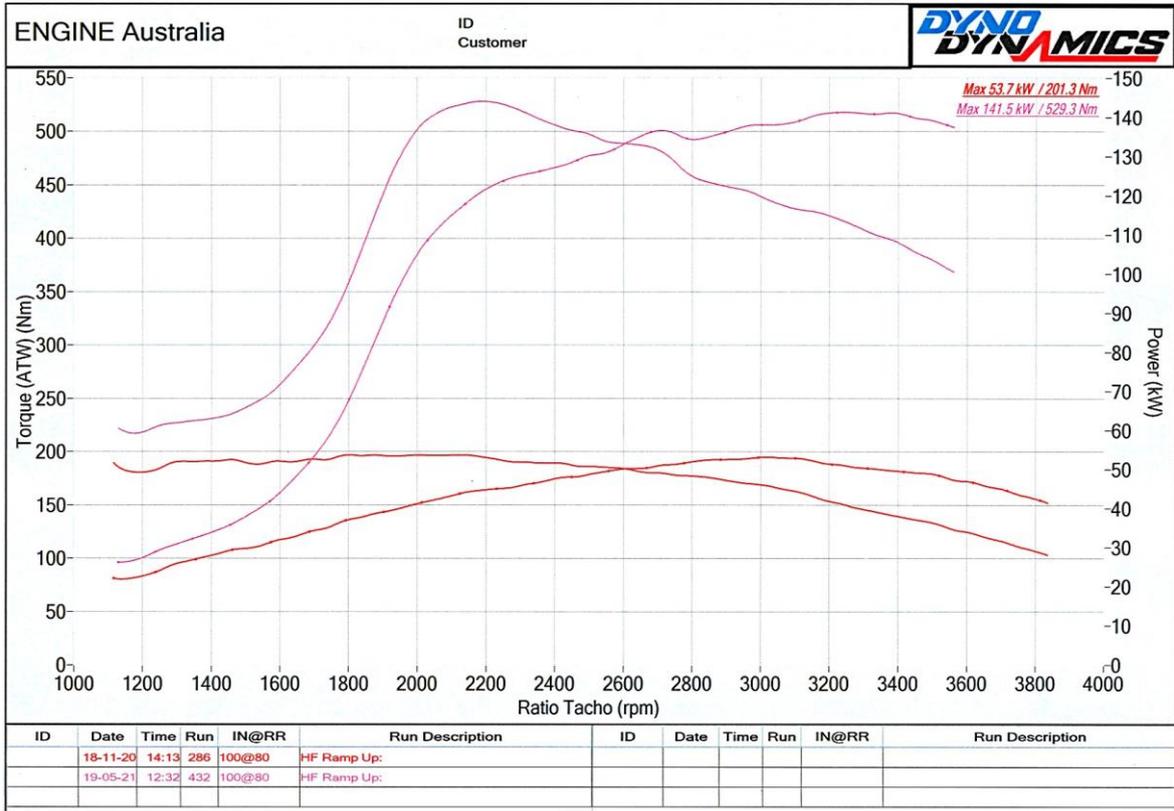
Graphic 1. Power and torque curves on chassis dyno for 1HZ-T stage 1 performance build.

The Troopy engine was rebuilt and left naturally aspirated for 10,000 kms. The engine was then given a stage 1 turbo upgrade to 135 kW. This is a 1600 – 3600 RPM engine. Graphic 1 below shows the rear wheel power and torque curves on the chassis dyno. The naturally aspirated engine runs a small vacuum and little blow-by. The turbocharged build is running 172 kPa (25 psi) inlet manifold boost and 198 – 227 LM (7 to 8 CFM) blow-by. As you would expect, the blow-by line shadows the boost line.

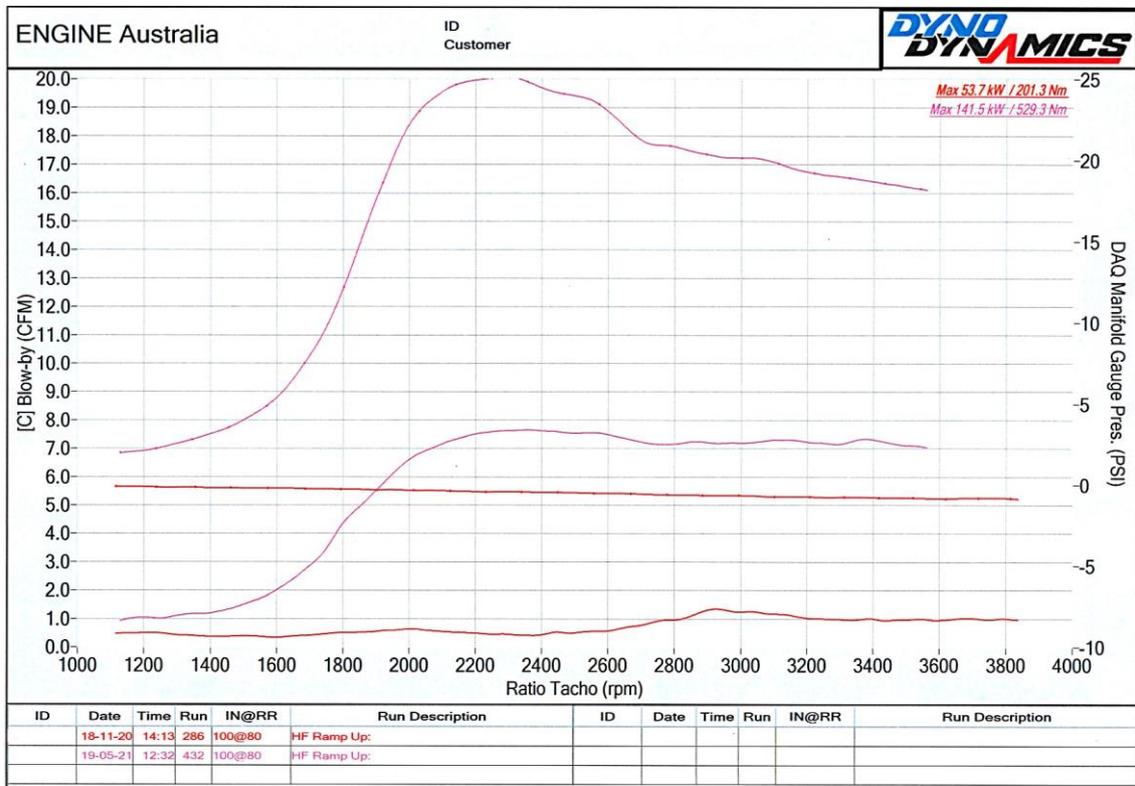
Graphic 2 shows the blow-by in CFM and the inlet manifold pressure for this engine in both build formats.

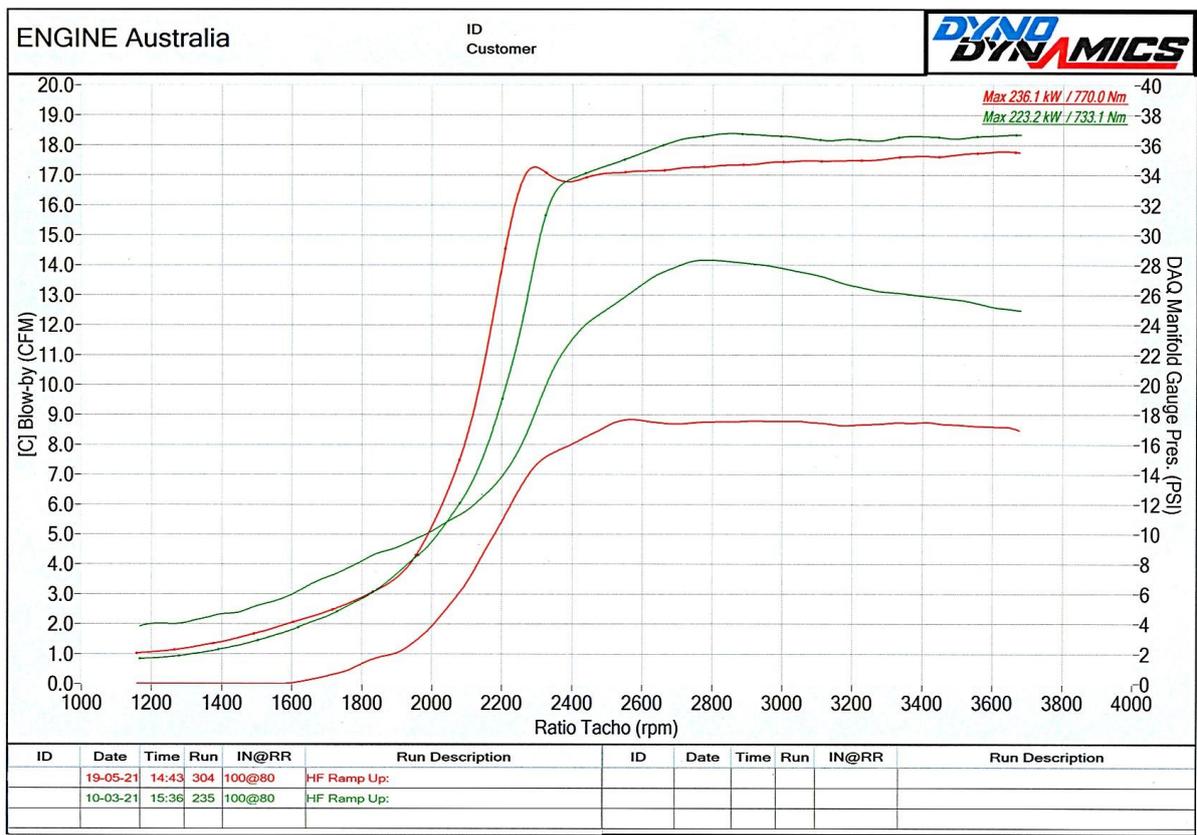
Graphic 3. The Diesel Performance Parts rings with Gapless Second Ring Technology resulted in a significant (36%) reduction in blow-by. This appears to continue to improve as the engine gets more operational hours.

The second engine was running a stage 3 turbo upgrade to 225 kW for 40,000 kms. The engine was stripped down, bores honed and a set of Diesel Performance Parts rings with Total Seal Gapless Second Ring Technology fitted. This refreshed engine ran 252 kW and 858 N.m of torque. The boost was wound back down to be close to the pre-Gapless rings reading. Graphic 3 shows the pre-Gapless rings blow-by vs inlet manifold pressure and the same for the Gapless rings but with boost adjusted down. The blow-by for around 248 kPa (36 psi) inlet manifold pressure was running up to 396 LM (14 CFM). With the Gapless Second rings installed, a similar inlet manifold pressure saw a blow-by of 255 LM (9 CFM).

The Gapless Second Ring Technology has not been fitted to the Stage 1 build engine at this stage. With 36% decrease in blow-by in the Stage 3 engine build, it is possible the Stage 1 build may see a drop in blow-by to 142 – 156 LM (5 - 5.5 CFM).

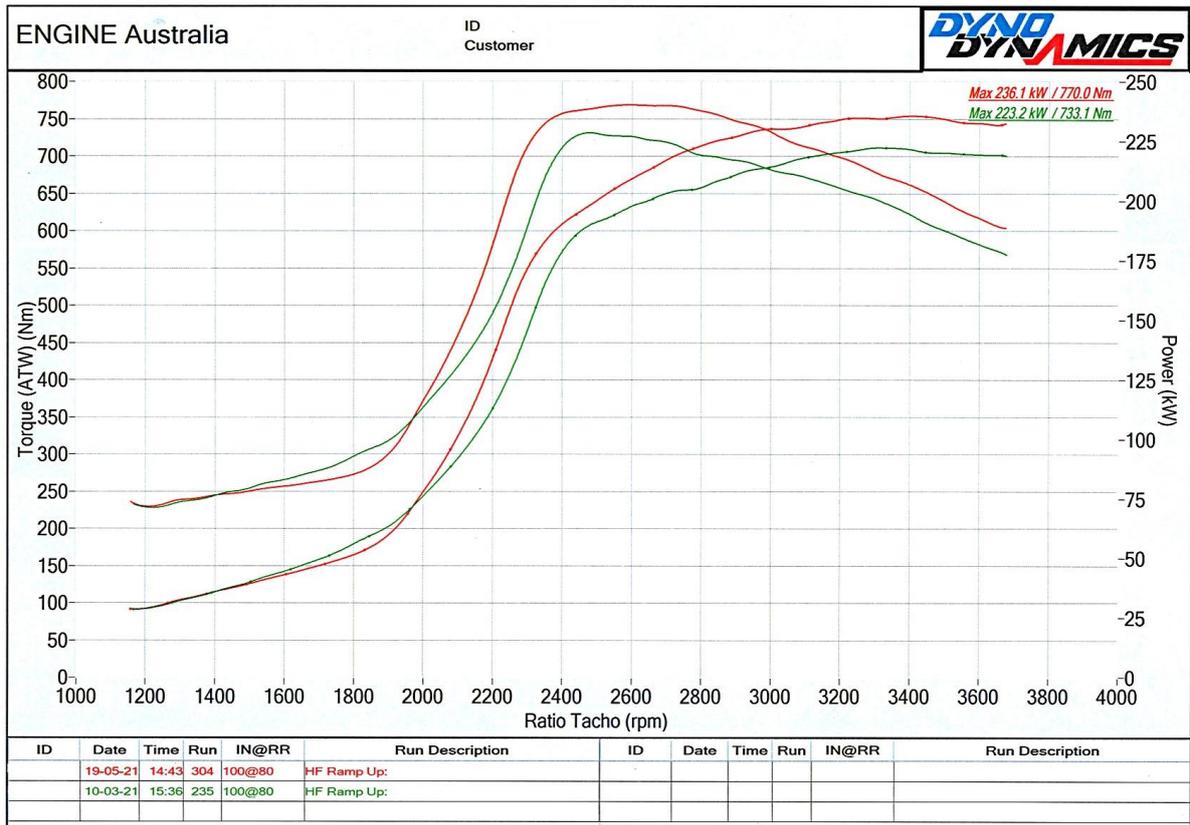
Graphic 4. Toyota 1HZ-T stage 3 performance build engine detuned to 248 kPa (36 psi) inlet manifold pressure.
