# Toyota 1HZ-T Overheating Issues

(Research and testing by Brandon Peltz and Brett Harth, Engine Australia)

May 2021

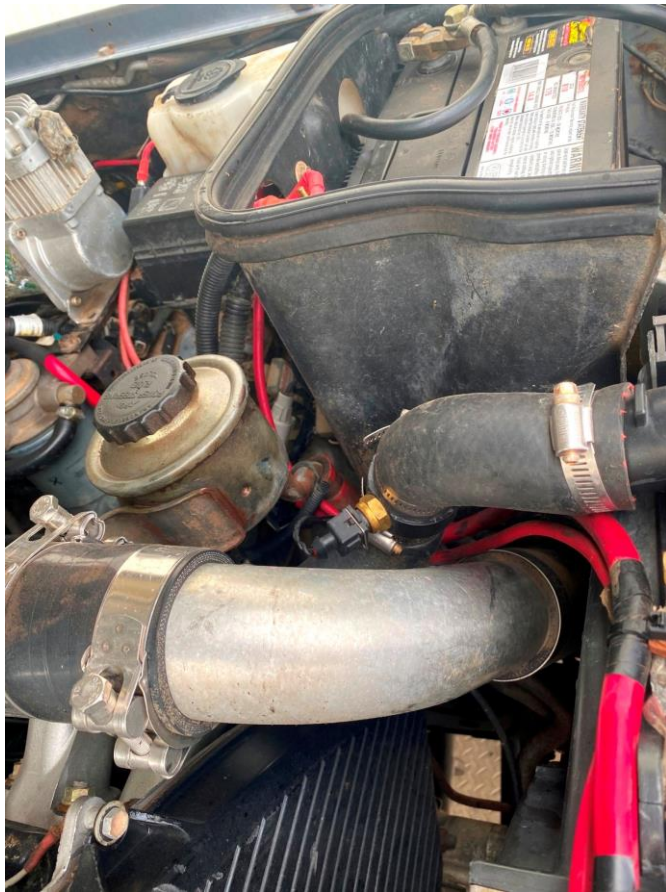
Radiator inlet and outlet temperature sensors for measuring temperature drop across the radiator in real time.

A second Davies Craig EWP Controller sensor was installed in the lower radiator hose to measure the temperature drop across the radiator. A second run in the afternoon saw temperatures of 102 - 103°C at 100 km/h and a temperature drop across the radiator of 4 - 6°C.

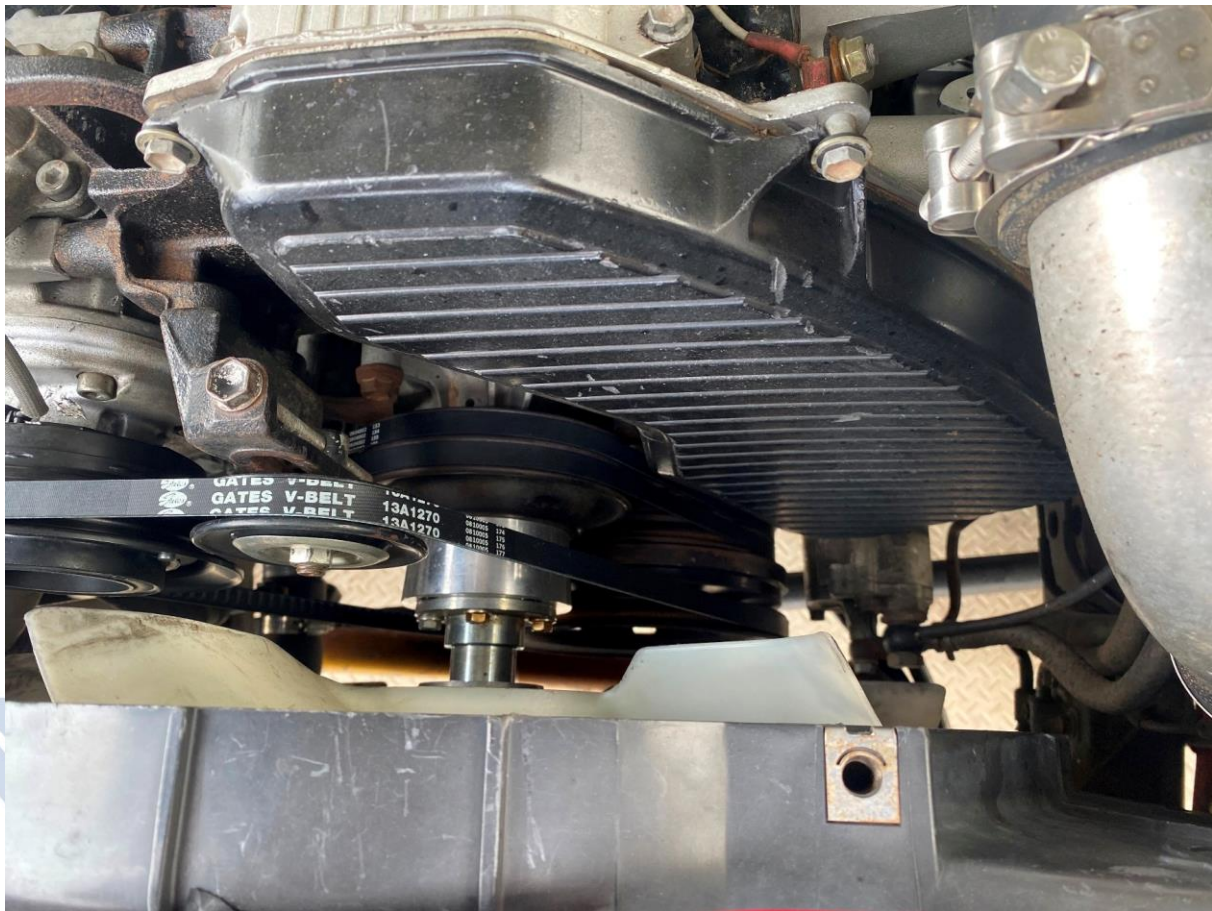
Diesel Performance Parts Hi-Flow Viscous Hub and Fan Kit installed to engine.

A **Diesel Performance Parts Hi-Flow Viscous Hub and Fan Kit** was fitted to the engine and taken for a test run at 2:45 pm and 30°C. The water temperature at 100 km/h and the A/C on was 82°C. Temperature drop

across the radiator was 14 – 16°C. At 110 km/h the temperature rose to 83 - 84°C, with across radiator drop of 12 - 14°C. Temperature recovery when slowing was noticeably quicker.

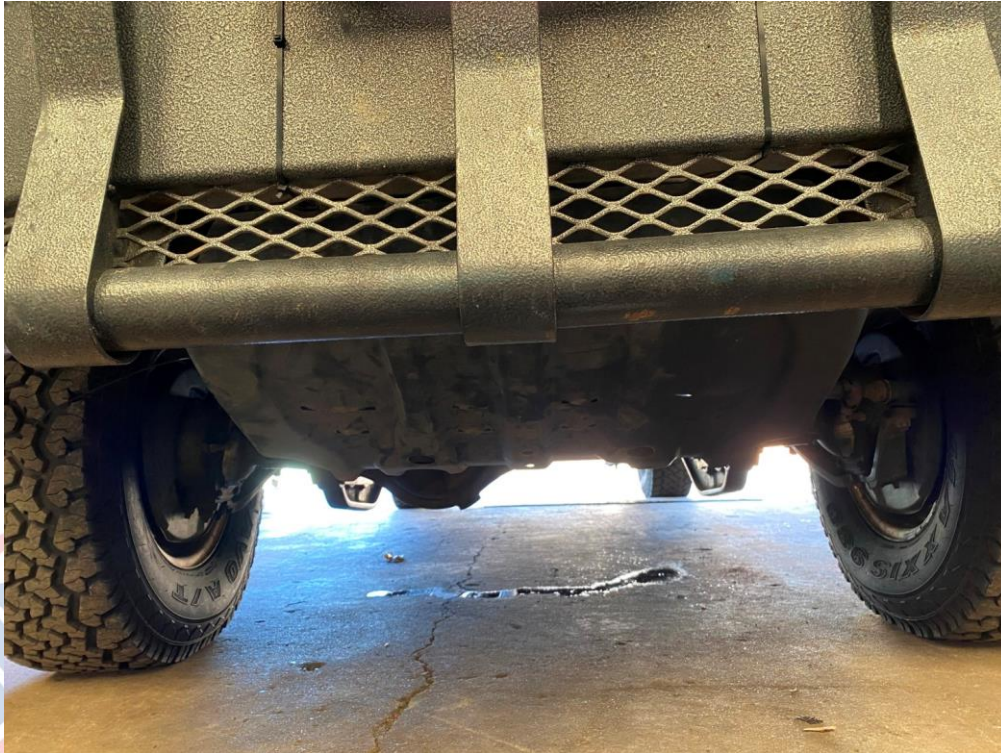
Air dam fitted under front of vehicle to see if would help extract hot air from the engine bay.

The following day a **temporary air dam was fitted under the front of the vehicle** to redirect air under the front differential. The idea was to create a low-pressure zone to help draw the hot air coming out of the radiator under the vehicle rather than into the engine bay. A run at 9:00 am and 25°C ambient temperature recorded 81 - 82°C water temperature at 100 km/h and a temperature drop across radiator of 14 – 16°C. At 110 km/h the temperature stabilised at 81 - 82°C and 12 - 14°C drop across radiator. The dam appears to have made some slight improvement, but questionable if it is worth the effort. **Cardboard cut-outs of large spotlights** were placed into the bulbar to simulate having spotlights fitted to the vehicle. A run at 9:30 am and 26°C ambient temperature recorded 86°C water temperature at 100 km/h, steadying to 82 - 83°C and a temperature drop across radiator of 10°C. At 110 km/h the temperature rose to 86°C, stabilised at 86°C and 10°C drop across radiator.

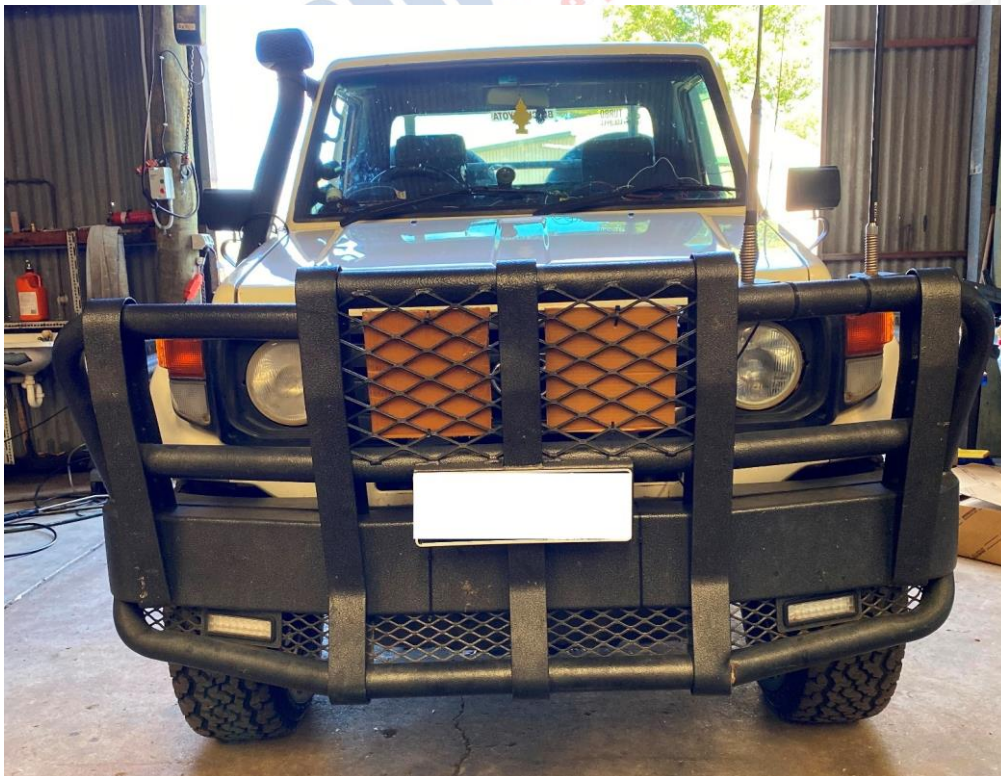
Cardboard cut-outs fitted to simulate spotlights.

The vehicle was run on the **Dyno and recorded 100kW, 360 Nm and AFRs of 20:1**. The genuine radiator was swapped back in and the spotlight cut-outs and air dam left in place and at 3:00 pm and 32 - 33°C ambient was taken for a run. It recorded 88°C water temperature at 100 km/h, steadying at that and a
